Rodeo Creek Watershed Assessment for Bankfull Channel Geometry Cross-Section Analysis

For
Contra Costa Resource Conservation District
And USDA Natural Resource Conservation Service

August 16, 2006

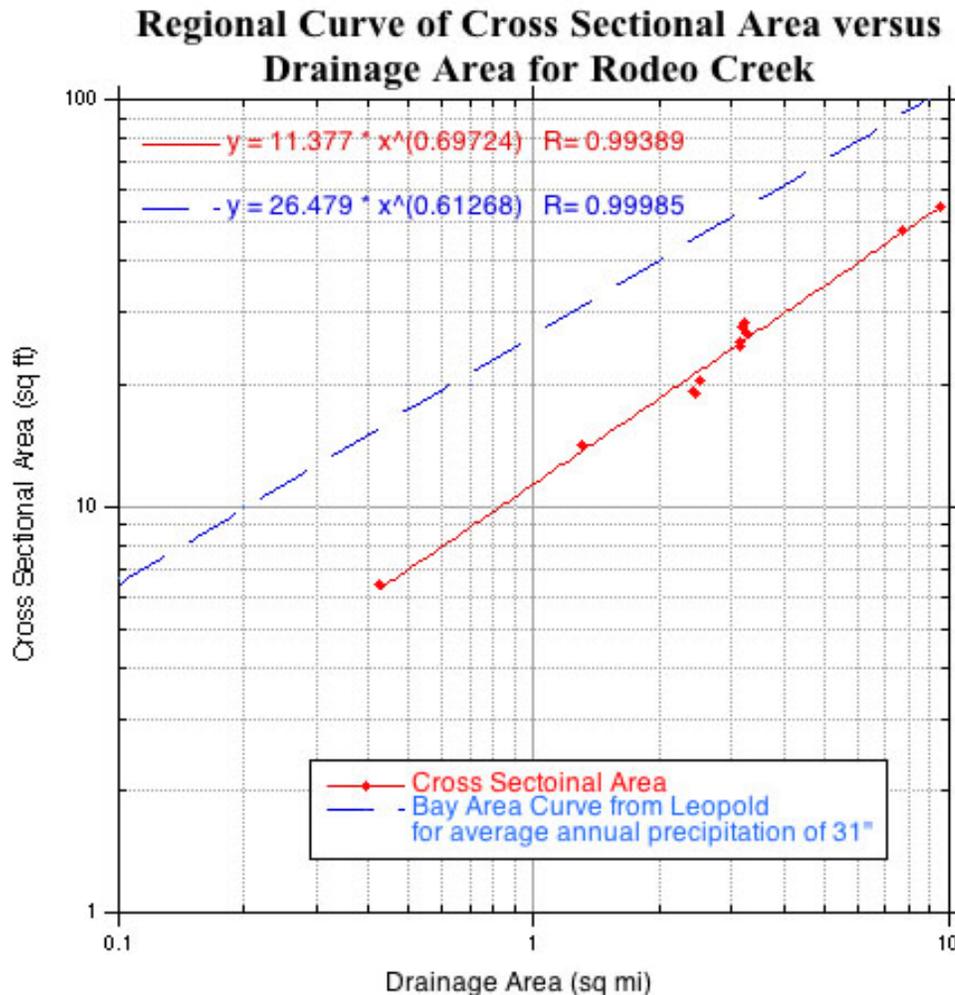
The 14 channel cross-section surveys obtained for this assessment have been conducted at locations where field indicators for bankfull channel were observed. Cross-section surveys conducted at each location and then plotted and the cross-sectional areas were calculated. Data was then plotted on a log/log graph along with the curve developed by

Luna Leopold for channel cross-sectional area for the greater San Francisco Bay Area. The curve developed by Leopold is higher than the local Rodeo Creek curve because of the higher average rainfall of the Bay Area than the project site (see figure below).

Additional analysis using XChannelPro to estimate flow rates at different elevations in the channel cross-section. This work was conducted as a check on the field identification of the bankfull elevation geomorphic work by calculating the bankfull elevation associated with the 1.5 to 2 year flow discharge. In the case of multiple potential bankfull field indicators, the one that most closely matched the calculated elevation of the bankfull flow was selected as the actual bankfull elevation and included in the regional curve.

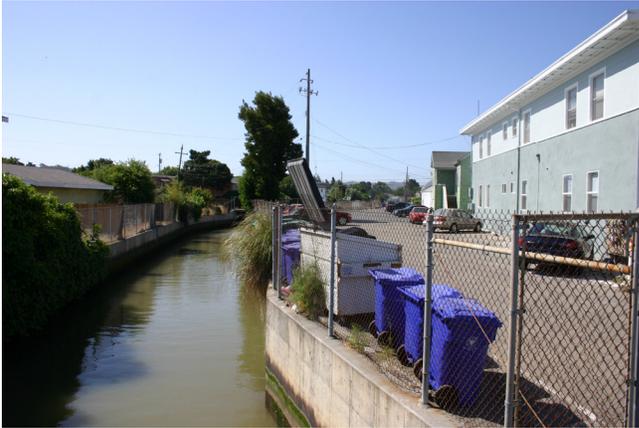
Reach 1 Open Box Concrete Culvert

Rodeo Creek is contained in an open concrete box culvert in the lowest reach. The right-of-way is extremely limited due to adjacent development. The Contra Costa County Flood Control and Water Conservation District (CCCFCD) is the owner of the flood control channel and retain maintenance access roads along both banks of the channel. No cross-sectional survey has been conducted on this reach.

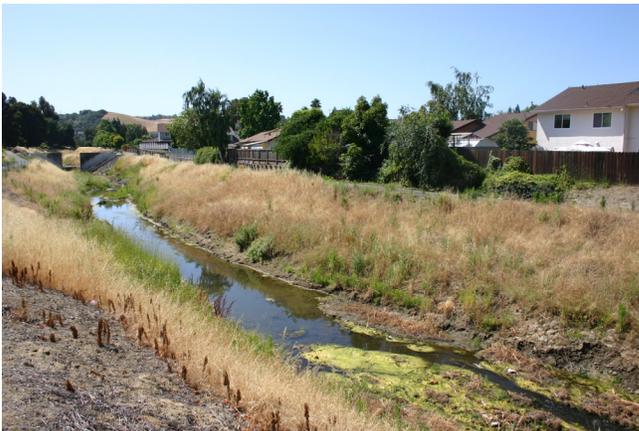
Reach 2: Earthen Bank Flood Control Channel

The creek transitions into a trapezoidal flood control channel with earthen banks approximately ¼ mile upstream from the mouth. Although the CCCFCD has performed sediment removal projects on this reach in the past, bankfull channel indicators were observed and a cross-sectional survey was conducted in this reach (*see cross-section 14*).

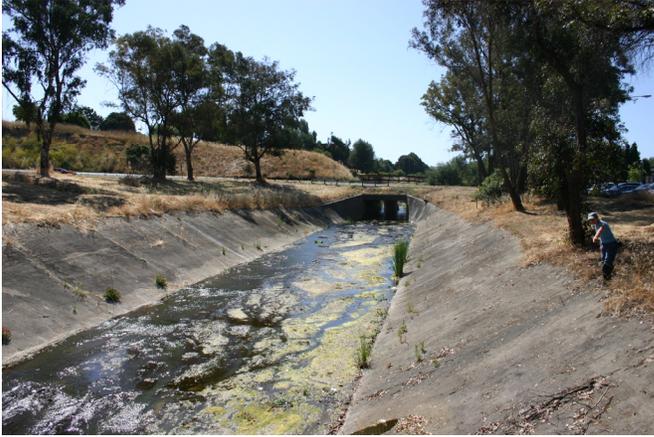
Reach 3: Concrete Trapezoidal Channel

This reach is located immediately upstream of the freeway and connects two earthen channel reaches of the CCCFCD flood control channel project channel. No cross-sectional survey was conducted in this reach.

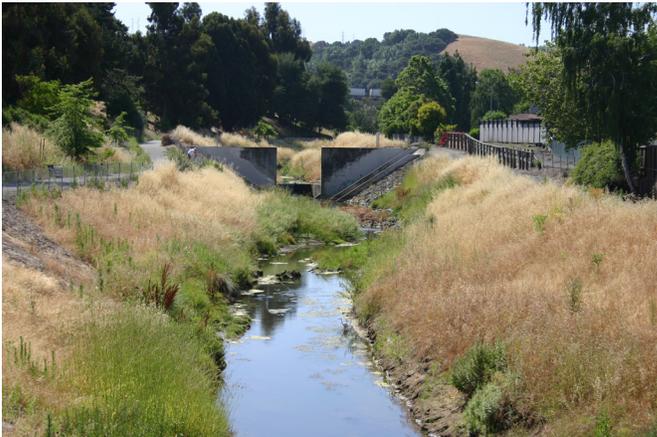
Reach 4: Earthen Bank Channels

This reach begins at the upstream end of the concrete channel and continues upstream to the BNSF railroad crossing. This reach contains numerous concrete grade control structures. A cross-sectional survey was conducted in this reach (*see cross-section 13*).

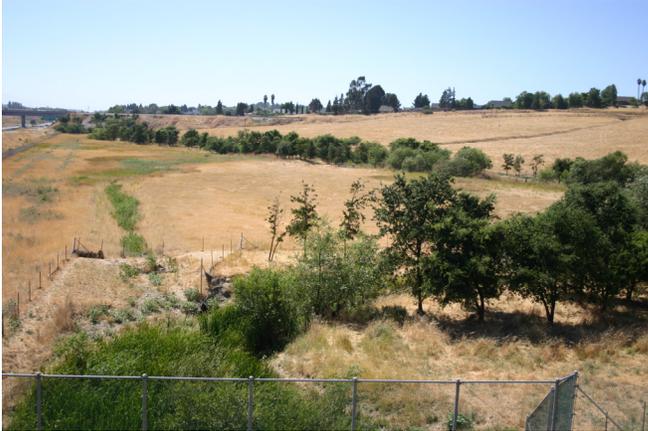
Reach 5: Vegetated Earthen Bank

Upstream of the Burlington Northern Santa Fe Railroad, Rodeo Creek returns to an unimproved earthen bank channel with a moderate riparian corridor. A cross-sectional survey was conducted in this reach (*see cross-section 12*).

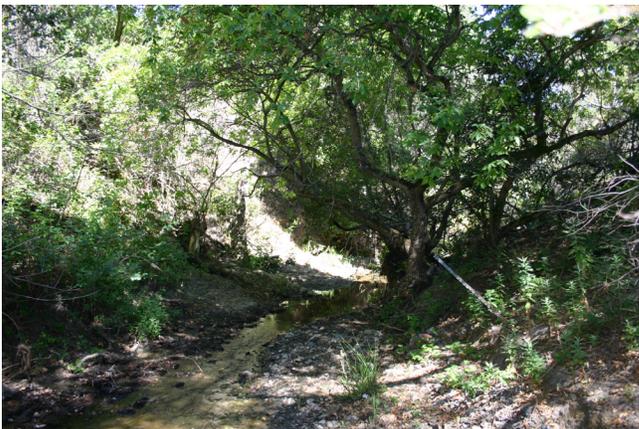
Reach 6 Earthen Bank & Dense Riparian Corridor (Franklin Canyon Golf Course)

Rodeo Creek within the Franklin Canyon Golf Course may represent the most healthy reach of the creek. Although the channel appears to have become significantly incised from its pre-European condition, the channel has achieved a state of equilibrium with associated floodplain and a dense riparian corridor. Cattle are excluded from this reach of the channel. Two cross-sectional survey were conducted in this reach (*see cross-section 10 and 11*).

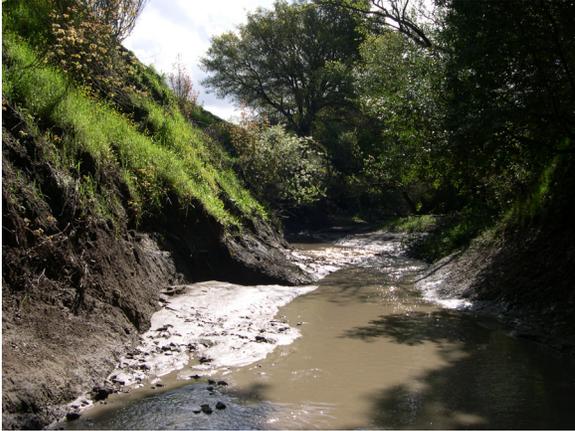
Reach 7: Actively Incising Earthen Channel (Fernandez Ranch)

The Rodeo Creek channel, upstream of the Franklin Canyon Golf Course, is actively incising and initiating massive bank failures. The incision has occurred at various periods over the past century with the most recent event having occurred during the winter of 2005/2006. The lowering of the Rodeo Creek bed elevation has initiated channel incision on all of the tributaries within this reach. Five cross-sectional surveys were conducted in this reach (*see cross-sections 5-9*).

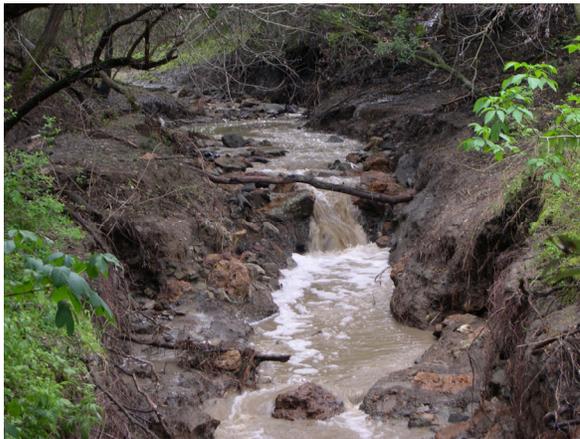
Reach 8: Highly Incised Earthen Channel (Burlington Northern & Santa Fe)

There are two headcuts with a total elevation change of over 15' at the upstream boundary of the Fernandez Ranch. These headcuts are moving upstream into channel reaches that are largely owned by the BNSF Railroad and that are experiencing massive bank failures due to previous channel incision. Two cross-sectional surveys were conducted in this reach (*see cross-sections 3 and 4*).

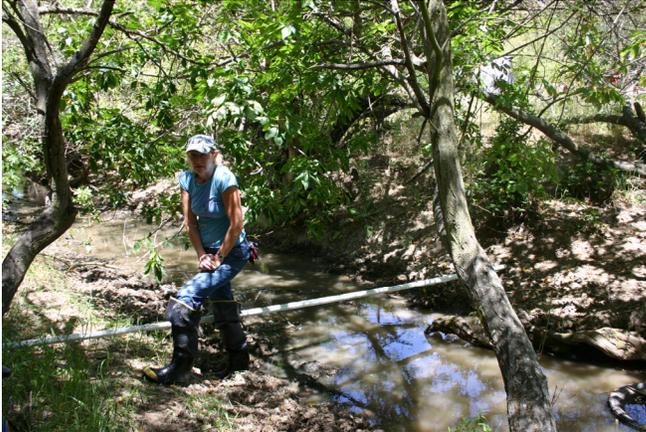
Reach 9: Pre-incision Condition with Active Floodplain.

Upstream of the Christie Road crossing, Rodeo Creek has remained non-incised, with vegetated banks and associated floodplain. The creek is owned by numerous private property owners and access was limited to one reach. Two cross-sectional surveys were conducted in this reach (*see cross-sections 1 and 2*).
